Manhole Inspection Summary

Manhole # S21E__002MH

Location Address: **1820 SARATOGA ST**

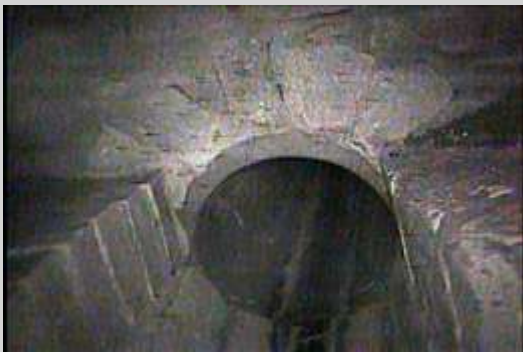
12 O'Clock Outflow

8 in. Circular Gravity Sewer
Pipe Out @ 12 O'Clock

Pipe Height: **8.4** (in.) Rod and Bar (Angled)
Pipe Material: **Clay** ☐ Pipe Lined
Invert Depth: **8.06** (ft.) Flow Characteristics: **Slow**
Deposits: ☒ None ☐ Mud ☐ Sludge ☐ **Debris** ☐ Grease
Silt Depth: (in.) Deposits Extent:
Infiltration: **None** Pipe Seal Cond: **Sound**

Drop: **None**
